# Event Recap Report: 1/12/10 Haiti Earthquake

## Introduction

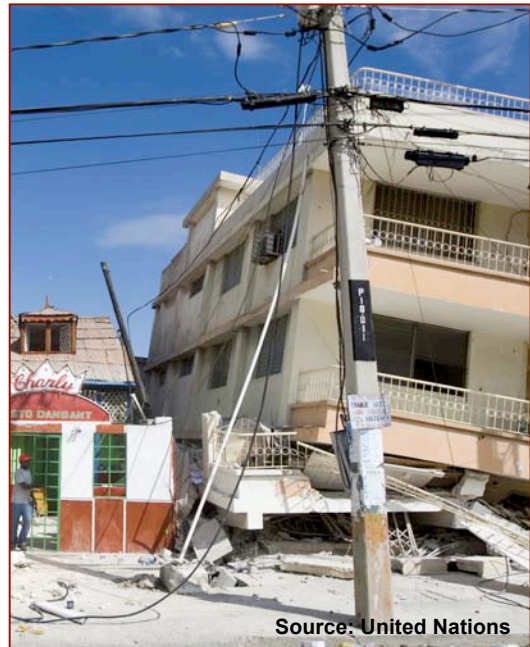
The earthquake brought widespread damage to the transportation infrastructures including the airport, seaport and roads. At the Toussaint L'Ouverture International Airport, the main control tower was seriously damaged and was unable to be used. The main runway sustained cracks but was able to be fully utilized. Air traffic control was unable to navigate incoming or outgoing aircraft for the first 48 hours after the main tremor. The United States Air Force delegated special combat controllers to create a makeshift control tower on the ground to begin directing private and commercial aircraft that were transporting aid and victims.

The Port-au-Prince Seaport sustained significant damage. According to officials, damage consisted of the collapse of cranes (see picture) and containers into the water, structural damage to the pier and an oil spill after an underwater pipeline broke. The damage was enough to render the facility unusable for immediate rescue operations. Foreign engineers and aid workers worked quickly to fix the port to enable large ships to arrive and deliver countless medical supplies and food, allowing the port to reopen after ten days. The Killick Seaport, located near the town of Carrefour, sustained minor damage, but the port was too small to handle large international ships. The Gonaïves Seaport, located to the north of Port-au-Prince,

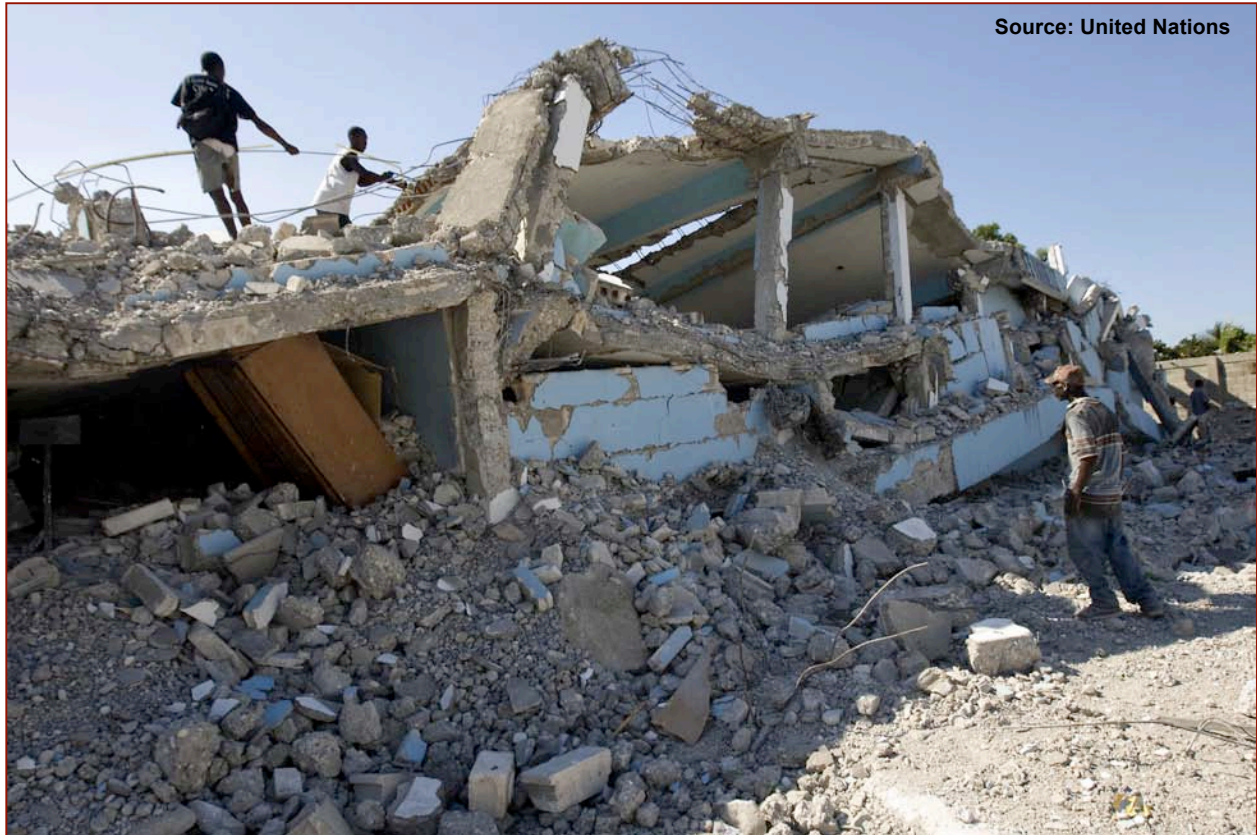
Source: United Nations

As is the case with many nations throughout the Caribbean, there are little to no building codes in Haiti. Due to such widespread poverty, most contractors are not able to afford large amounts of concrete (much of which is imported from the United States). Due to this reasoning, it is possible that many contractors tend to cut corners by adding sand into the cement mix, leading to a structurally weaker building. Also, the high cost of steel normally leads to contractors not using reinforcing steel bars with the concrete or using the bars incorrectly. In addition, few homes have wood framing, mainly due to the extremely limited supply of lumber due to mass deforestation.

After the January 12<sup>th</sup> earthquake, engineers reviewed photos of some of the collapsed multi-story structures and noted that most had slender columns supporting heavy concrete slabs. These photos also confirmed that the amount of steel reinforcement in many cases was minimal, if it was present at all. This type of construction is consistent with areas that are not earthquake-prone, where the structure is expected to carry only vertical loads such as those due to the weight of the building material. However, earthquakes shake structures both horizontally and vertically along with torsion. With slim columns and little reinforcement, the columns in Haiti's structures crumbled as they lacked the shear and bending strength. Engineers indicated that higher-strength columns would have been needed to resist the earthquake forces, but they also would have needed to be properly connected to the beams or floor slabs with additional steel bars running from the columns into the beams to provide continuous transfer of the forces from one structural element to another.
